Periodic Inspection of Nawiliwili Harbor Breakwater, Kauai, Hawaii

Armor Unit Monitoring for Period 1995-2001

Robert R. Bottin, Jr., and Daniel T. Meyers

June 2002

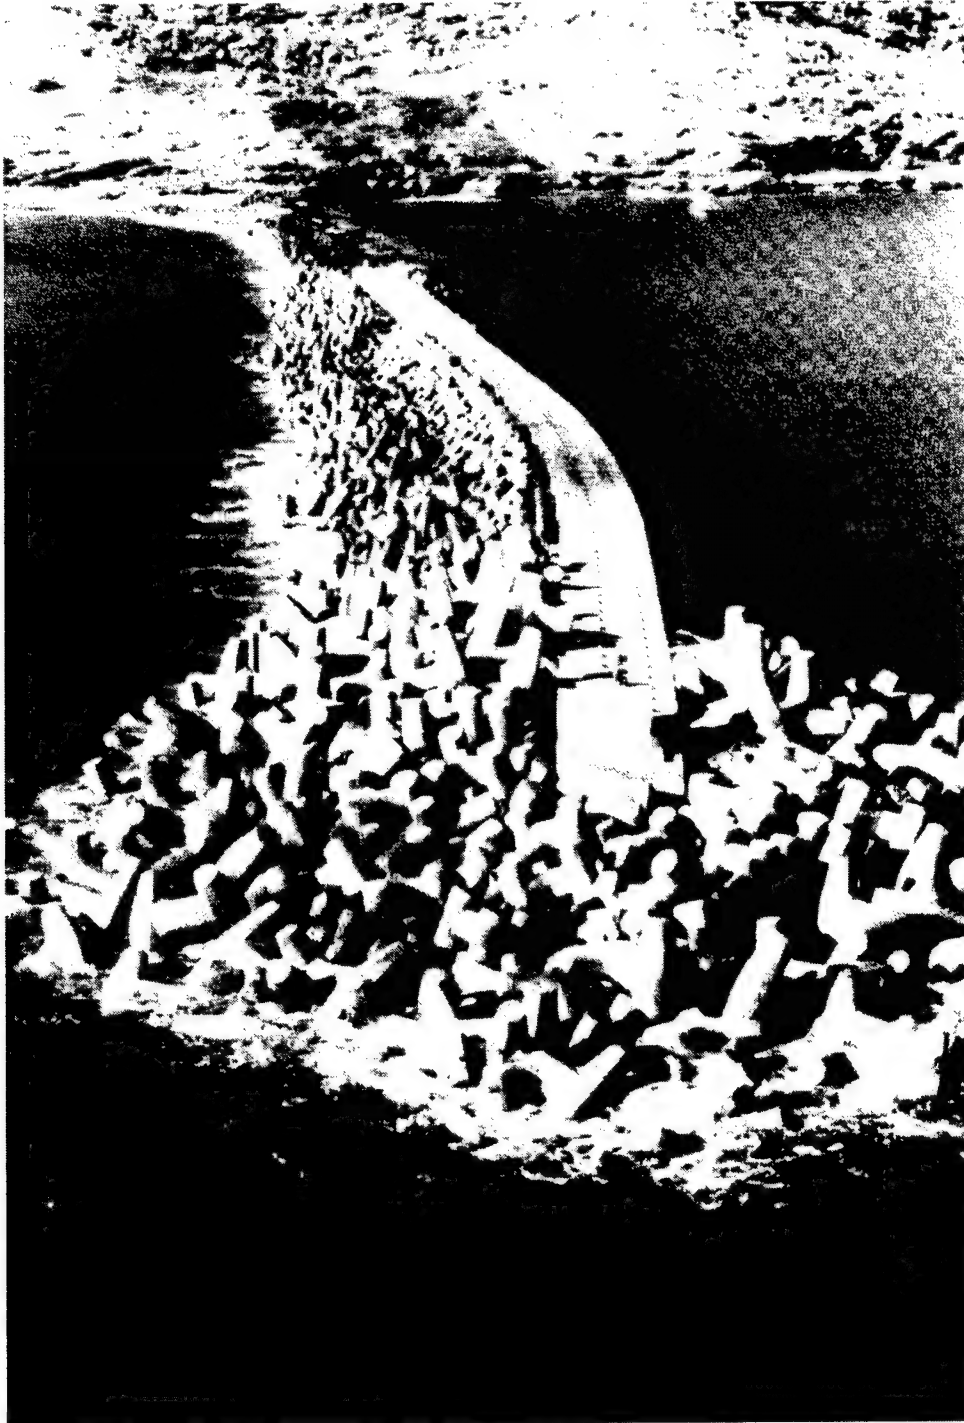
Figure 8. Aerial photograph of Nawiliwili breakwater (1995)

Initial monitoring of the Nawiliwili breakwater was completed in October 1995 as part of the "Periodic Inspections" work unit of the MCNP Program (Bottin and Boc 1996). Work included armor unit targeting, limited ground surveys, aerial photography, photogrammetric analyses of armor units, and a broken armor unit survey. The information obtained during the monitoring effort established base level conditions for the breakwater. Precise positions of targeted armor units were obtained as well as centroid data and orientations of the targeted armor units. The broken armor unit survey revealed that 70 broken/cracked armor units existed on the structure. An aerial photo of the Nawiliwili breakwater in 1995 is shown in Figure 8.

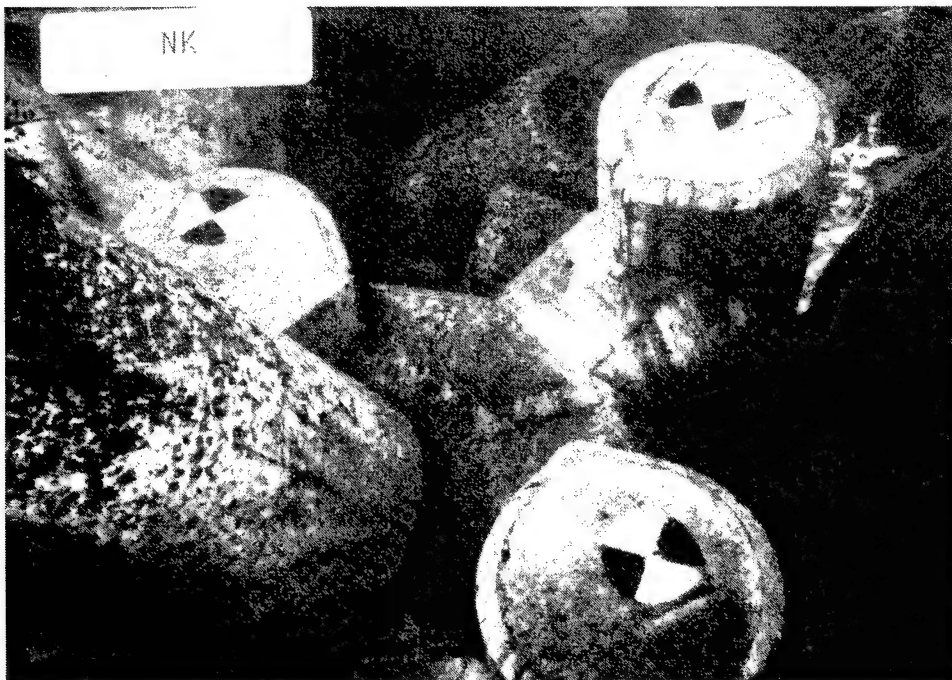
Figure 11. Example of a targeted 17.8-ton tribar

Each armor unit selected for targeting was painted with three, 30.5-cm (12-in.) diam targets. The targets were divided into four quadrants that were painted alternately white and black. This style of contrasting target provides a precise center point for which measurements can be made by both land surveys and photogrammetric work. A high quality epoxy-based marine paint was used to minimize the need for repainting, and a 2.54-cm (1-in.) cross was chiseled at the center of each target for identification in subsequent surveys. Each targeted unit was labeled conspicuously with two, 15.2-cm (6-in.) high white letters, the first being "N" for Nawiliwili and the second being an identifying letter for the particular unit. Each target on its respective armor unit was identified with a single 15.2-cm (6-in.) white numeral labeled "1" through "3." Examples of targeted armor units are shown in Figures 11 and 12.

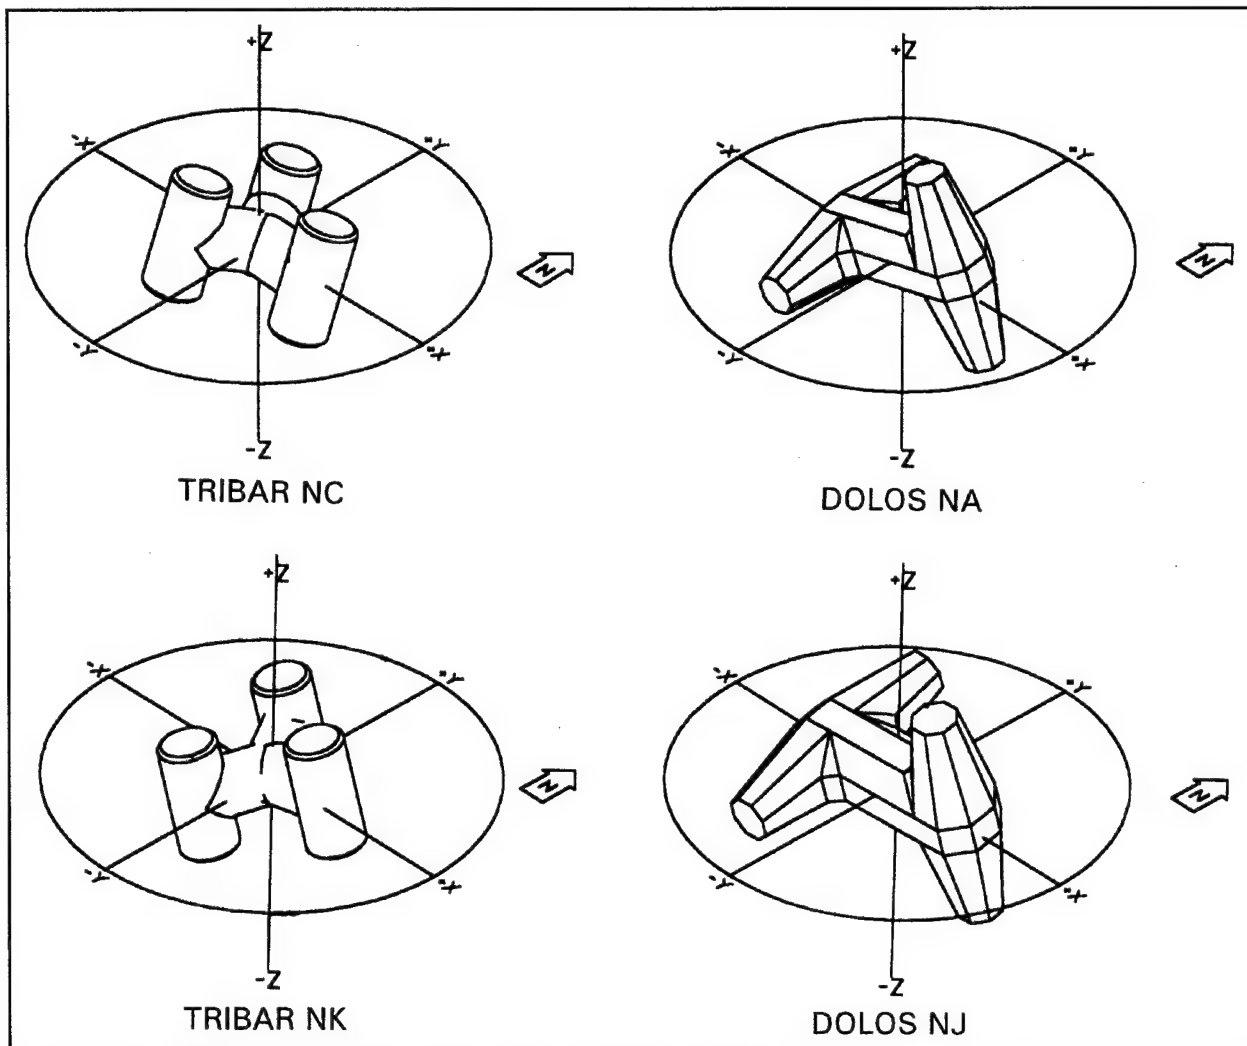
Figure 16. Representative targeted armor unit positions relative to x, y, and z axes

With the x, y, and z (easting, northing, and el) coordinates defined for each target on the various armor units, the coordinates of the centroid (center of mass) of each targeted armor unit were computed for the 2001 aerial survey. In addition, the position of each armor unit relative to the x, y, and z axes was determined. Figure 16 shows, in 3-D, the orientation of representative armor units to the three axes. The centroid coordinates of each targeted armor unit and each unit's orientation (rotation angle relative to the x, y, and z axes) are presented in Tables 3 and 4, respectively, and compared with the aerial survey results of 1995. Maximum movement of the centroids was 0.104 m (0.34 ft) and 0.113 m (0.37 ft) in the horizontal and vertical directions, respectively, while average movements were 0.027 m (0.09 ft) and 0.043 m (0.14 ft) in the horizontal and vertical directions. Changes in the rotation angle of the armor units varied from 0.0 to 10.2 deg with an average of 0.8 deg. These data indicate minimal movement of the targeted armor unit centroids.
